**O & M INSPECTION REPORT  
FOR NAVIGATION AND SHORE PROTECTION PROJECTS**

1. Project Name: Aunu'u SBH
2. Date of Inspection: April 7, 2004
3. Inspection Personnel:

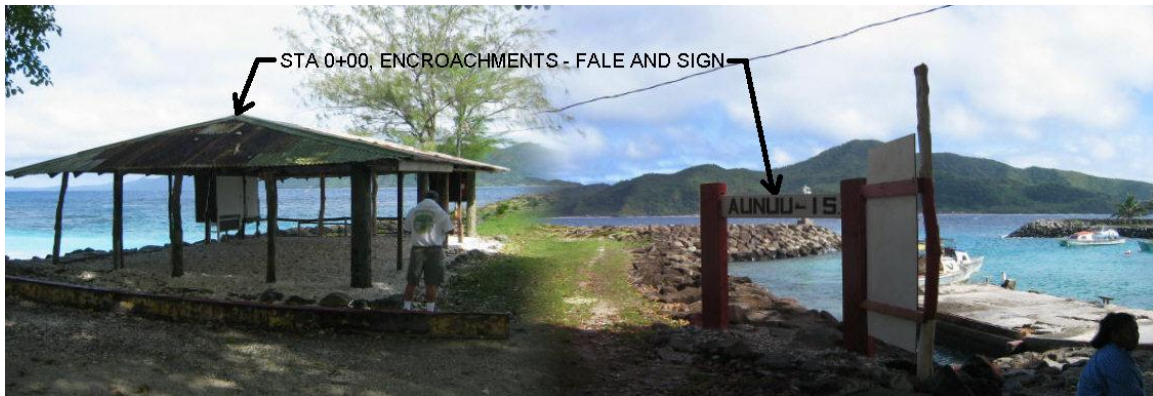
a. Sta. 0+00, HS, Notice encroachments - Fale and sign. POH is coordinating with its Real Estate office to address the issue of encroachments on Aunu'u Harbor. Juvenile trees from previous year have been removed.

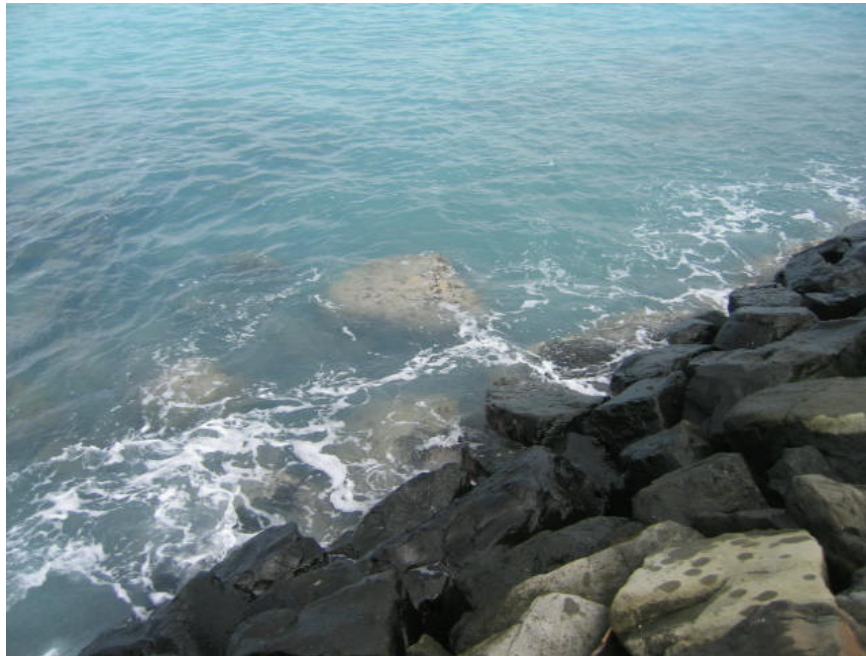
b. Sta. 1+00, OS, Monitor lea. Dislodged armor stone at the toe.

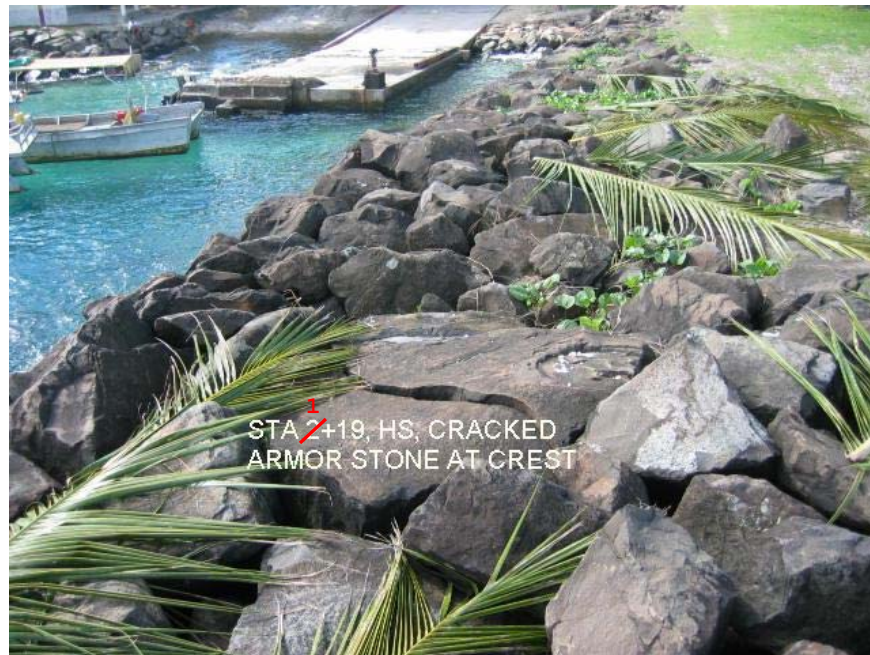
c. Sta. 1+19, HS, Cracked armor stone. (2003 Photo)

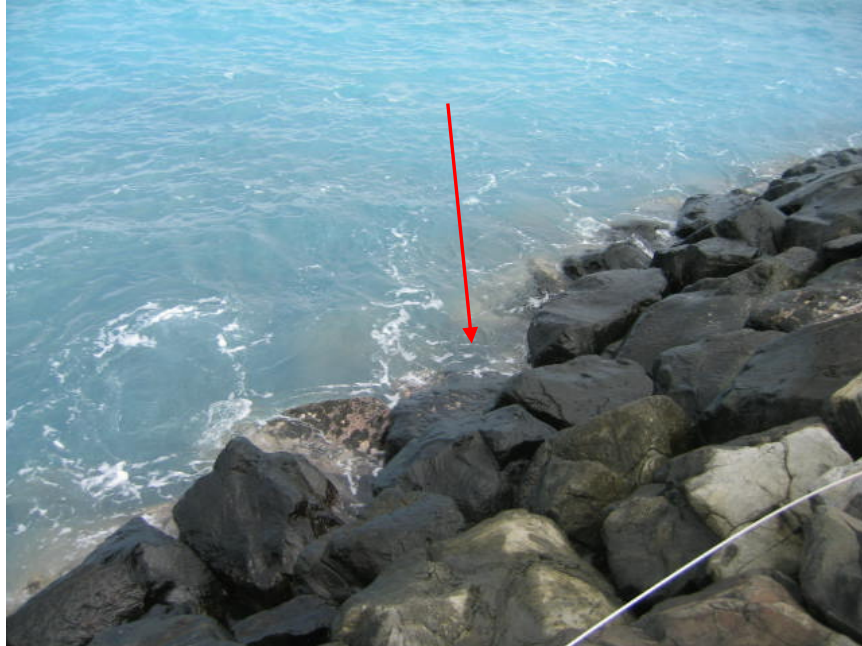
e. Sta. 1+80, OS, Missing armor toe stones.

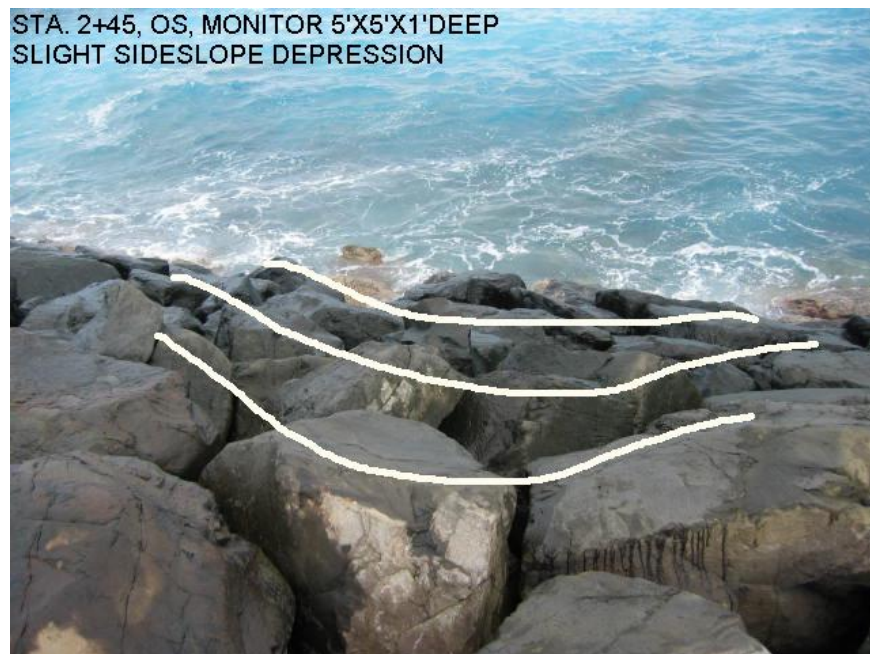
f. Sta. 2+45, OS Sideslope, Monitor slight depression. (2003 Photo)

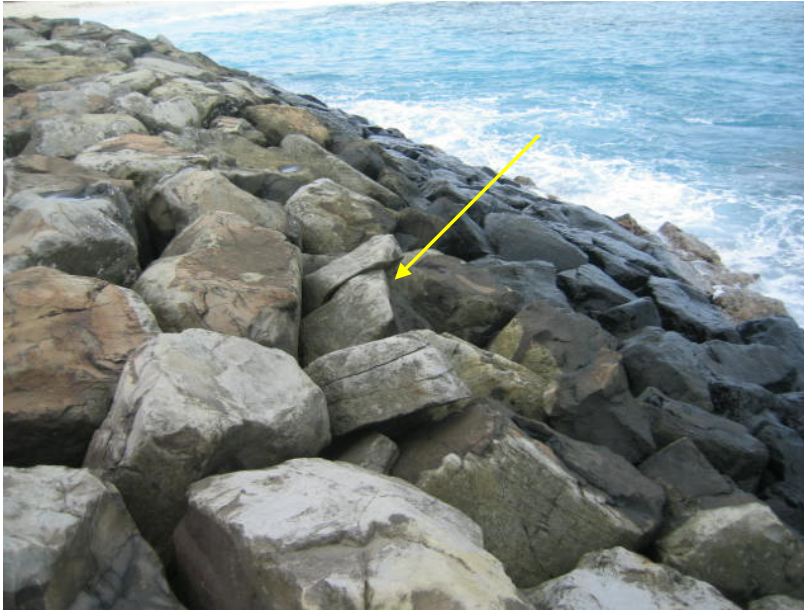
g. Sta. 2+85, OS, Monitor sideslope depression and cracked armor stone at hinge.

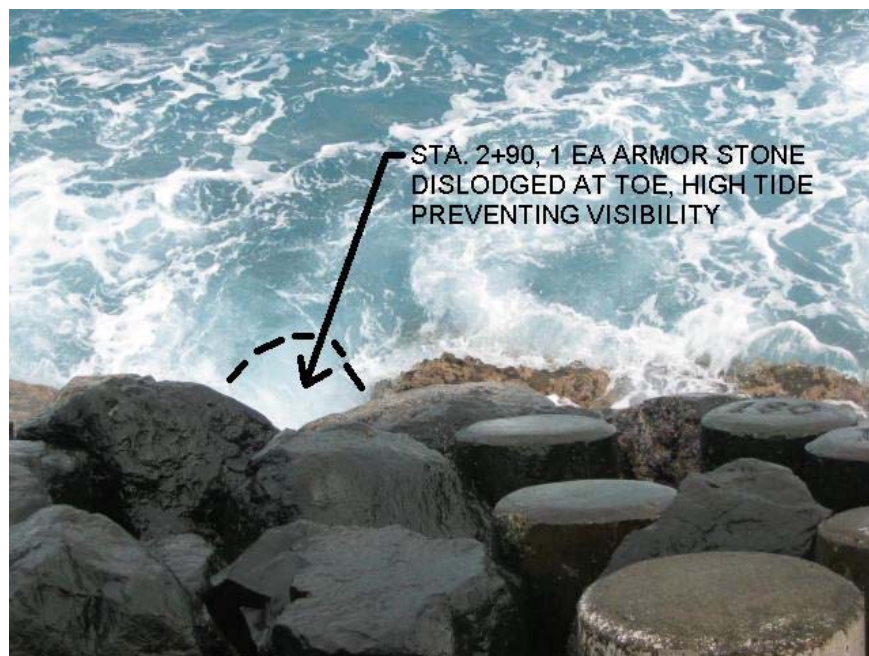
h. Sta. 2+90, OS, Monitor 1 ea. Dislocated armor stone at the toe.  
(2003 Photo)

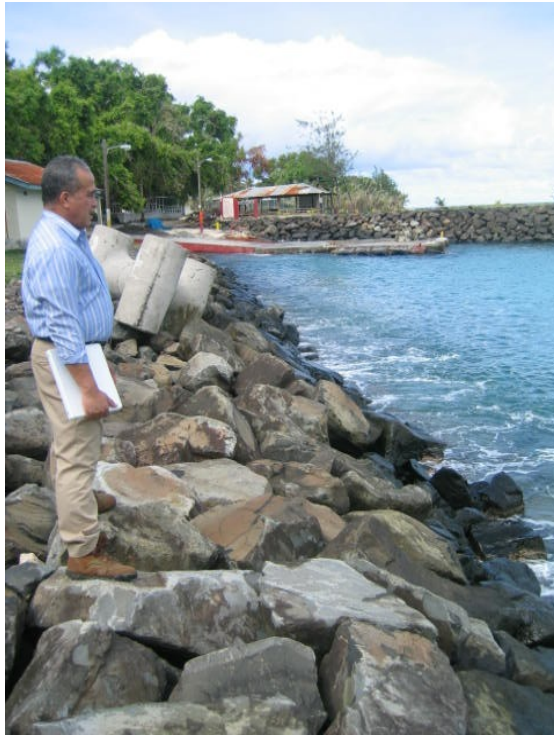
a. Sta. 1+20, Portions of the wave absorber have been dismantled. The armor stones loosely dumped into the area, and are not keyed or fitted.

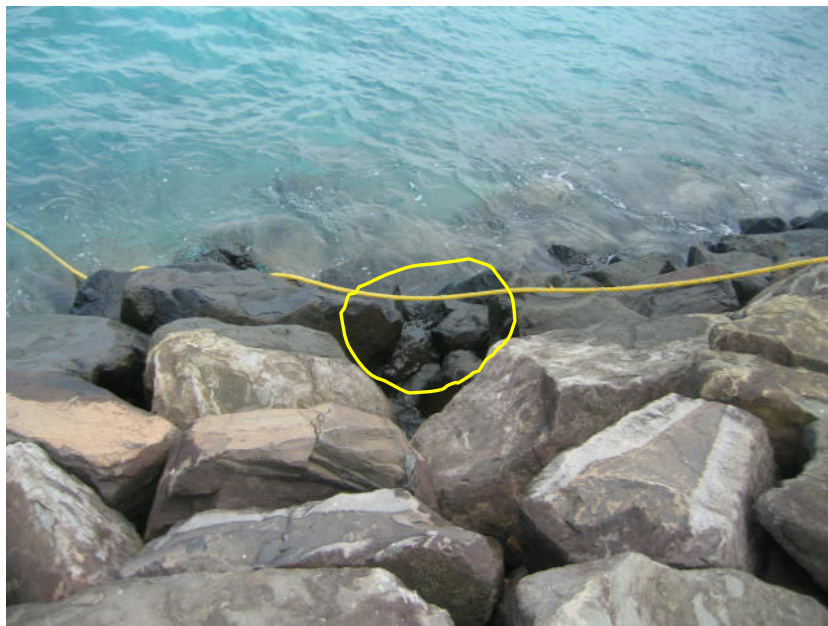
b. Sta. 1+50, sideslope armor stone missing, underlayer exposed.

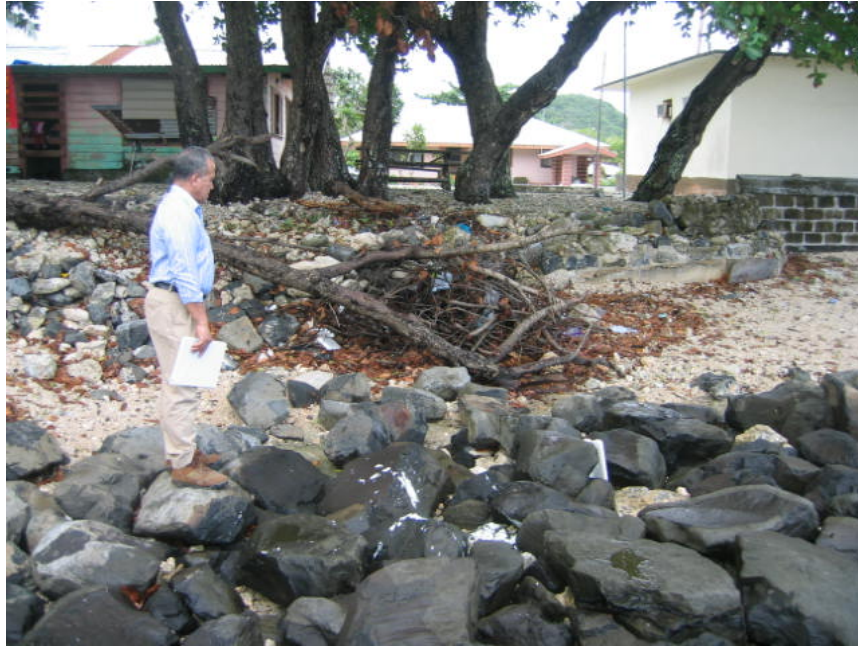
c. Sta 1+75, Large amounts of debris and smaller armor stone thrown landward of wave absorber, indicative of structure overtopping.

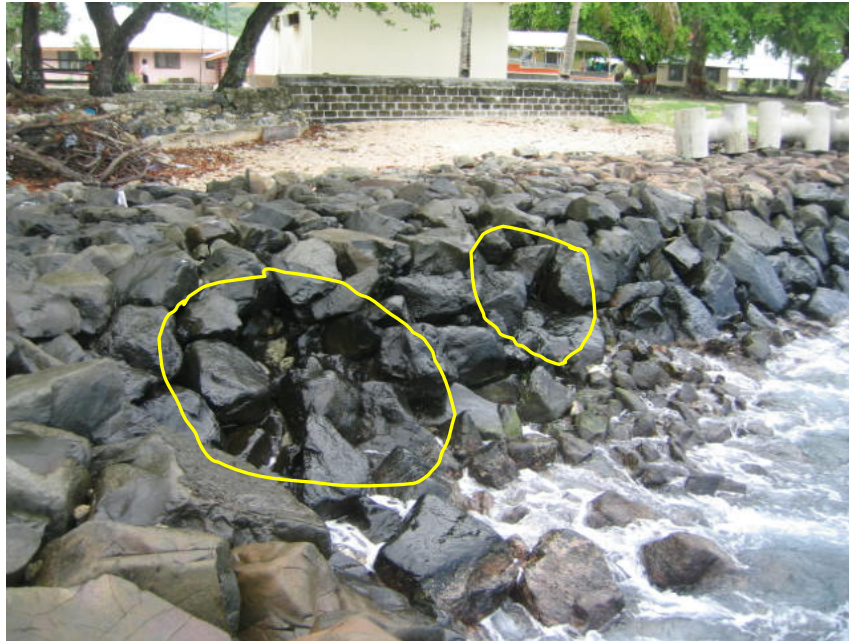
d. Sta. 1+99, Monitor changes @ 10' diameter x 5' deep void, and 4'x4' void on the sideslope, UL exposed. Armor stones dislodged and resting adjacent to toe. Minor changes since 2003.

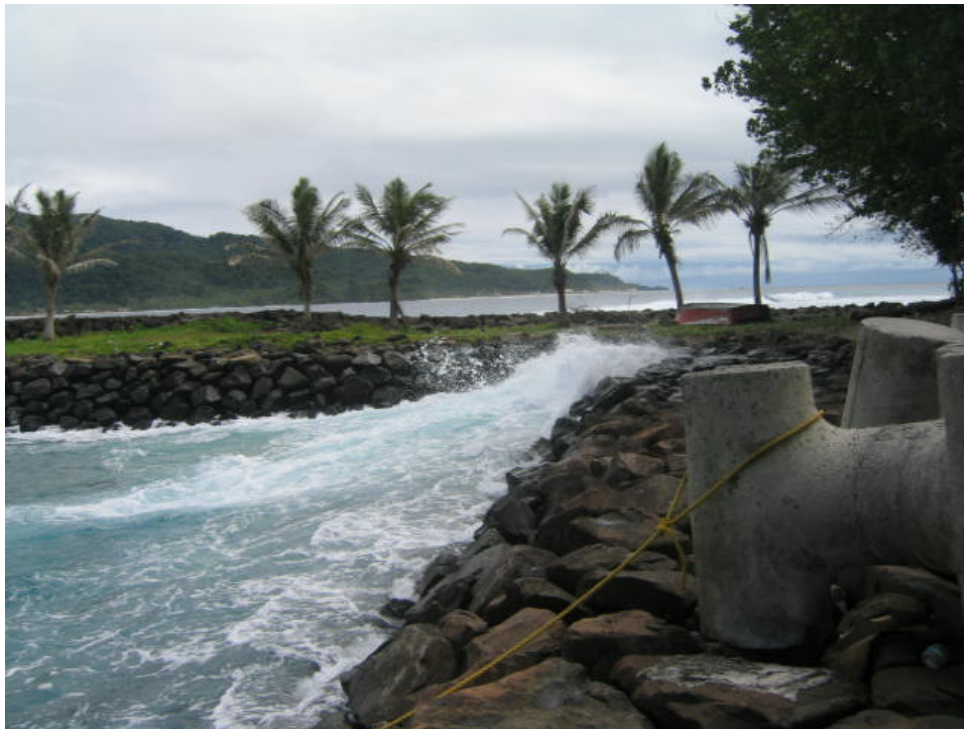
f. Harbor surge and overtopping at joint between wave absorber and North Revetted Mole.

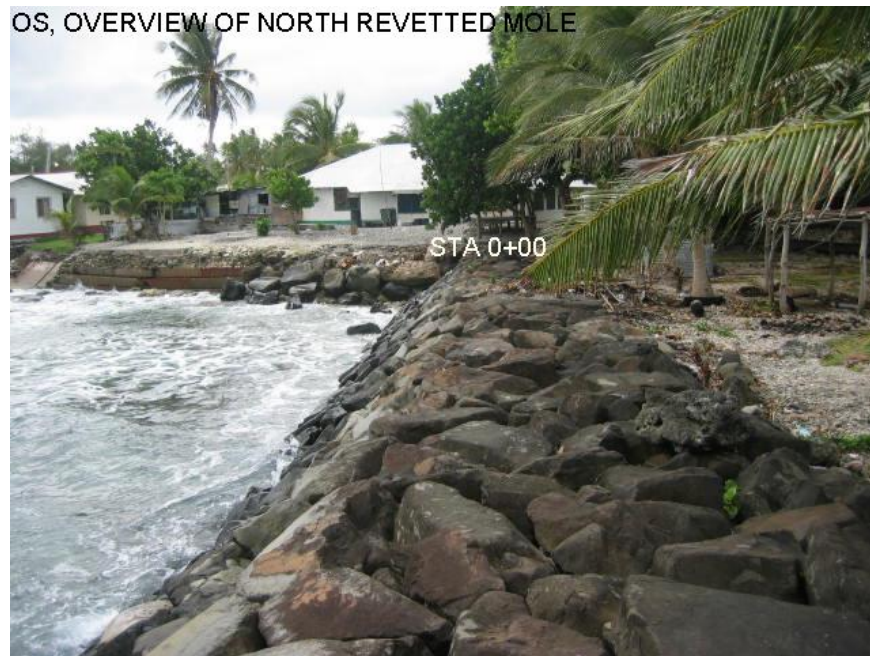
- a. Sta. 0+00, OS, Vines and trees have been removed from structure.  
(2003 Photo)

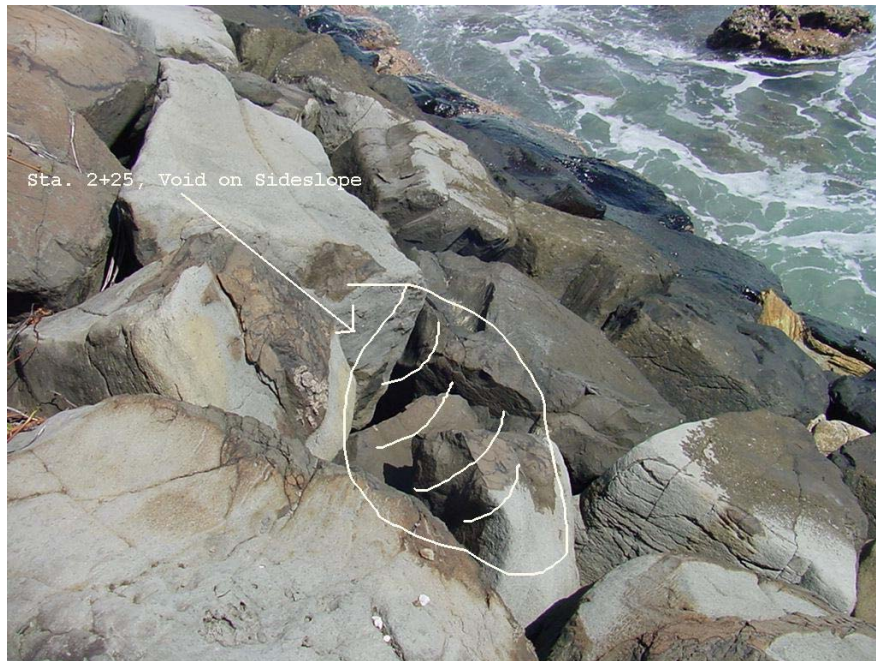
c. Sta. 2+25, OS, Monitor void and dislodged toe armor stone (2002 PHOTO).

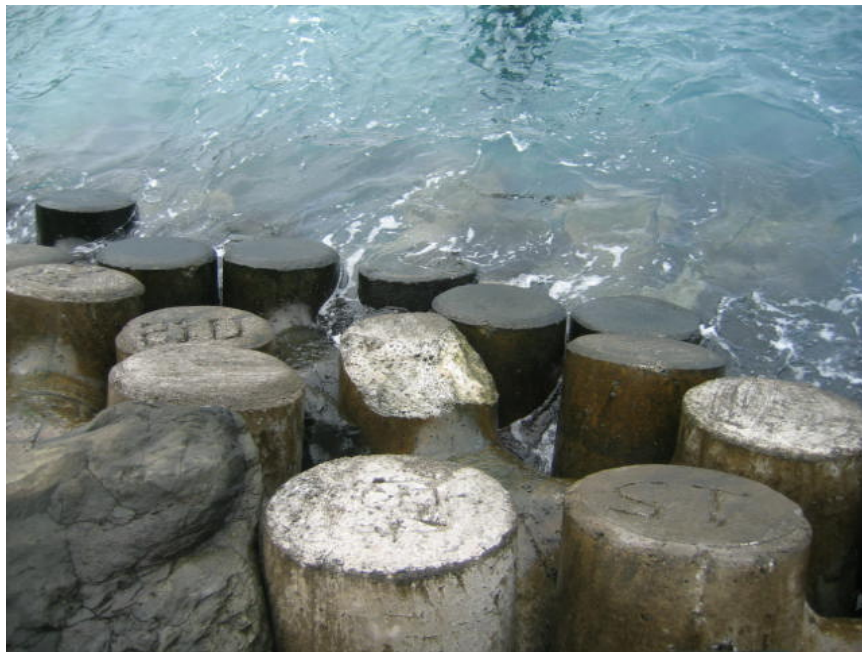
d. Sta. 2+75, HS, Chipped tribar #184.

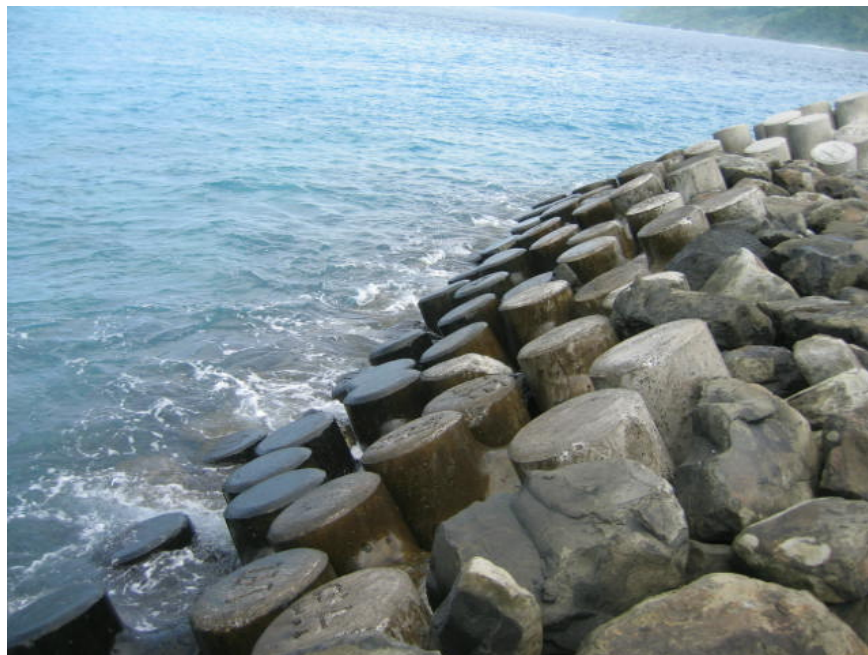
e. Overview of HS slope of North Revetted Mole, primarily good condition.

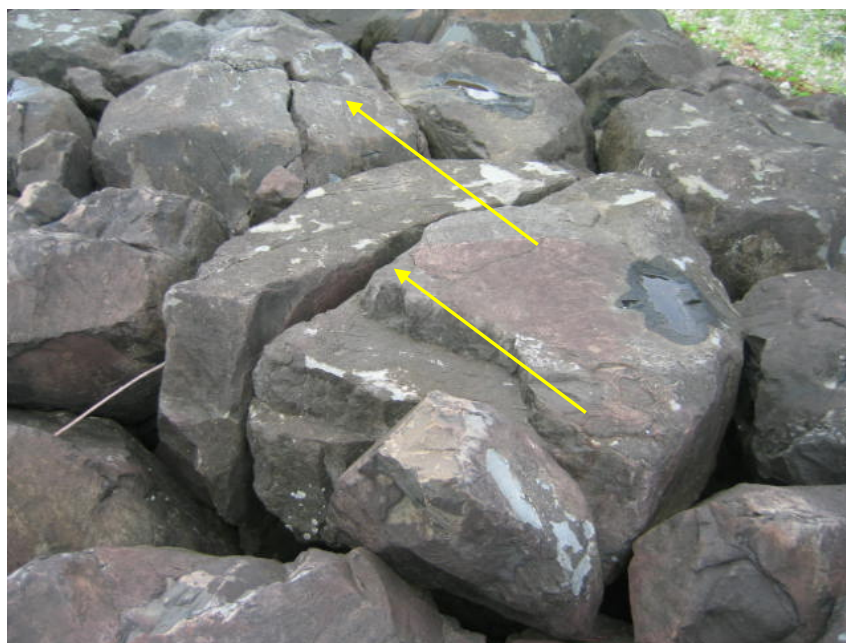
f. Several cracked armor stones along HS crest of revetted mole (no station available), monitor.

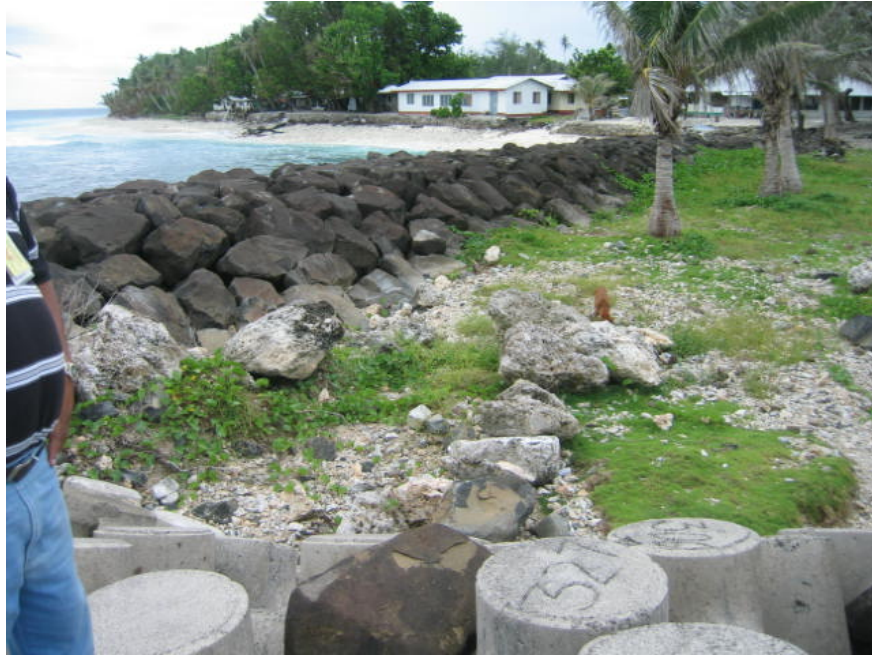
g. Sta 2+80, Several small armor stones thrown landward of structure onto mole area, indicative of structure overtopping. No noticeable voids in structure.
